**Flood Control Project Maintenance  
Levee Inspections**  
**LMA District Cover Sheet**  
**Spring 2020 Levee Inspection Results**

**American River Flood Control District**

**Spring 2020 Levee Inspection Results**

Waterway			Bank	Unit Miles
Unit No. 01 Arcade Creek			Left	2.08
	Spring (March - May)	Summer (June - August)	(September - November) Fall	Winter (December - February)
Unit Maintenance Rating (Fall Only)				
Date of Inspection	3/25/2020 - 3/25/2020			
DWR Inspector	Luz Dial			
Accompanied By	Gilbert Gutierrez ARFCD

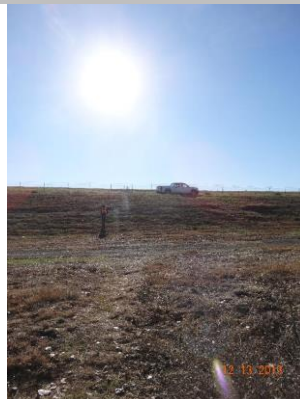
Photo 1 of 3 : UCIP\_SP\_2020\_31254\_57217.jpg

Comment Code						
Inspector Comment						
DS_ID:24330 FS_ID:31254 EP_NO: 15041 Repair Type: Non-Urgent Crossing Status: Indicator Found UCIP Comments: 08/16/2017 DWR Deferred Maintenance Project (DMP), Vince Rodriguez, forwarded email received from Tim Kerr, General Manager of American River Flood Control District (ARFCD) with file "DWR Eligible Pipes Found in ARFCD" from ARFCD that shows the ownership and location of the pipes Tim Kerr investigated. Owner of this crossing is identified as the City of Sacramento, ARFCD Staff Notes indicate landfill drain pipe (Permit# 15041) id#3424. (DWR UCIP - O. Magana) 12/13/2013 Hole present on riser located on landward side--contact owner. Additional pipe found in waterward berm. Unable to confirm if this pipe section is part of crossing--size does not match. Unable to find CM standpipe on waterward side. (DWR UCIP - O. Magana) FIELD_STRUCT_DESC: 18-inch corrugated metal drainage pipe through the levee at an unknown depth. Steel cutoff wall around pipe at center of levee. Storm drain gate on landside (LS) shoulder. Drainage ditch on LS. Corrugated metal standpipe on waterside (WS). Rock-filled ditch on WS. (18-inch pipe authorized under Permit No. 15041, 1993 - City of Sacramento) [Additional Reference(s): DWR Levee Log, 2002] FS Date: 12/13/2013

Overview of waterward side.

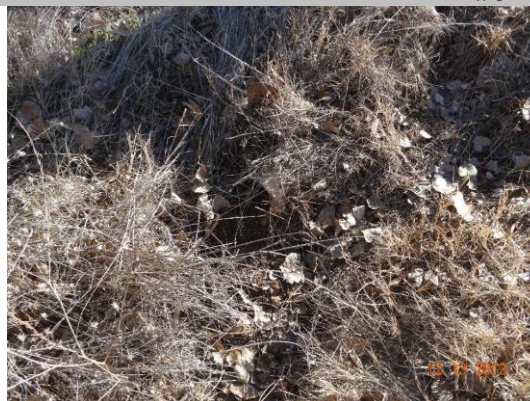
Photo 2 of 3 : UCIP\_SP\_2020\_31254\_57219.jpg

Pipe buried by vegetation--unable to determine if pipe goes through levee.

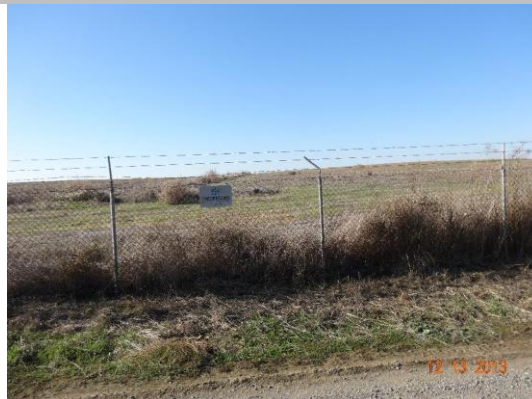
Photo 2 of 3 : UCIP\_SP\_2020\_42128\_56572.jpg

View of landward side.

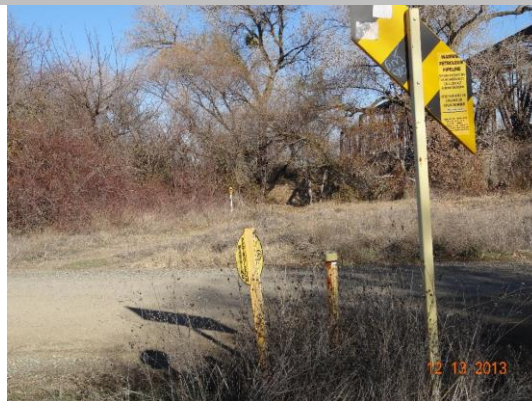
Photo 3 of 3 : UCIP\_SP\_2020\_42128\_56576.jpg

View of markers visible on landward side.

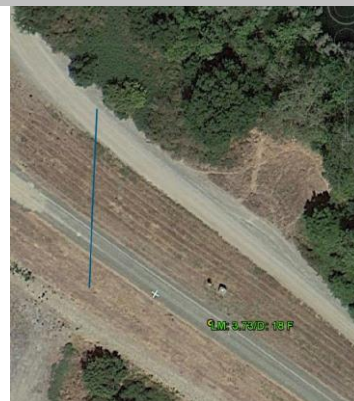
Photo 1 of 3 : UCIP\_SP\_2020\_31255\_57226.jpg

LM Start	3.75	Rating **	M	Issue No.	759
LM End	3.75	Issue Type +	En	Location *	
Category	Supplemental			GPS Latitude/Longitude	
				Start	End
Item	DWR UCIP Field Study			38.587724 °	38.587724 °
				-121.449554 °	-121.449554 °
DWR ID	24335				
Comment Code					
Inspector Comment					
DS_ID:24335 FS_ID:31255 EP_NO: N/A Repair Type: Non-Urgent Crossing Status: Found UCIP Comments: Control box is non-functional parts have been removed. Unable to confirm diameter size and status--City of Sacramento incitates a 24 inch sewer main not 18 inch. Need to contact owner to confirm size. FIELD_STRUCT_DESC: 18-inch sewer main through the levee. Concrete manhole on the waterside (WS) slope. [Additional Reference(s): DWR Levee Log, 2002] FS Date: 12/13/2013

Approximate alignment provided by City of Sacramento and DWR-UCIP confirmed location of sewer line is indicated by green label.

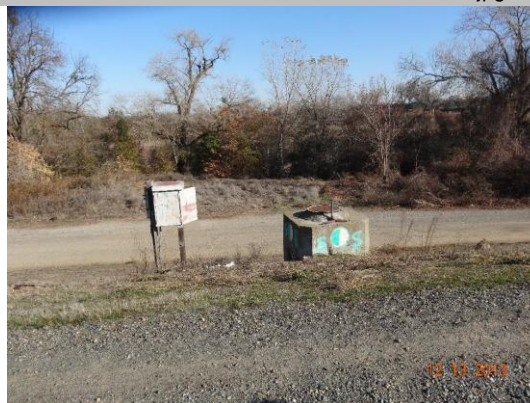
Photo 2 of 3 : UCIP\_SP\_2020\_31255\_57223.jpg

View of waterward side.

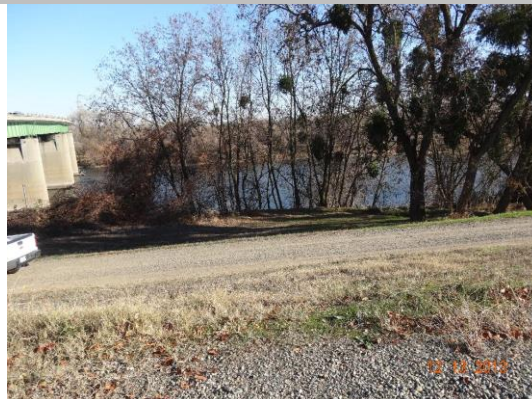
Photo 2 of 3 : UCIP\_SP\_2020\_52708\_55291.jpg

View of waterward side.

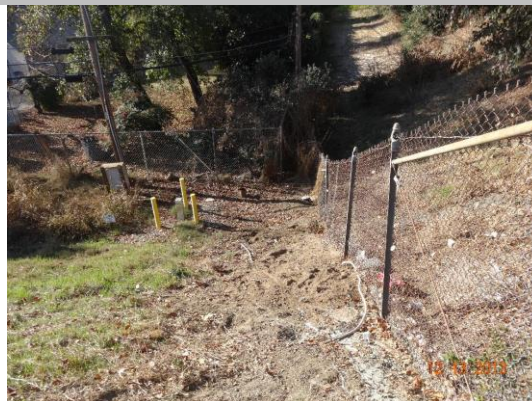
Photo 3 of 3 : UCIP\_SP\_2020\_52708\_55295.jpg

Sewer line along fence line on landward side--riser near back fence.

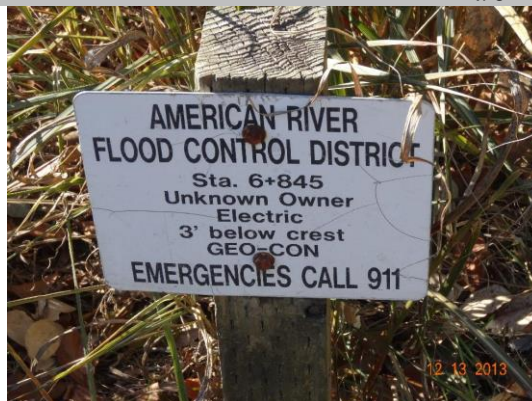
Photo 1 of 3 : UCIP\_SP\_2020\_29054\_53588.jpg

LM Start	3.89	Rating **	M	Issue No.	761
LM End	3.89	Issue Type +	En	Location *	
Category	Supplemental			GPS Latitude/Longitude	
				Start	End
Item	DWR UCIP Field Study			38.586479 °	38.586479 °
				-121.447574 °	-121.447574 °
DWR ID	24337				
Comment Code					
Inspector Comment					
DS_ID:24337 FS_ID:29054 EP_NO: N/A Repair Type: Non-Urgent Crossing Status: Found UCIP Comments: Unknown owner--Need to coordinate with DWR Inspector and CVFPB. FIELD_STRUCT_DESC: 3-inch communication polyvinyl chloride (PVC) conduit through levee, 2 feet below the crown. [Additional Reference(s): DWR Levee Log, 2002] FS Date: 12/13/2013

Electrical conduit marker located on landward toe.

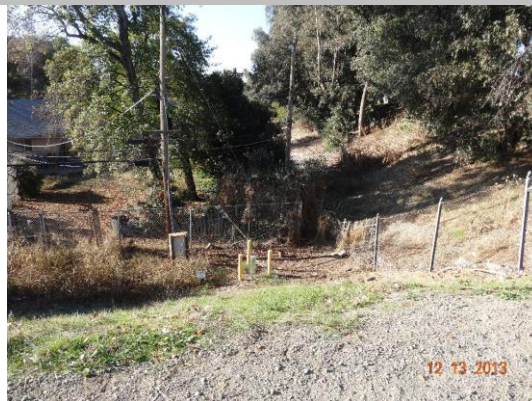
Photo 2 of 3 : UCIP\_SP\_2020\_29054\_53587.jpg

View of landward side.

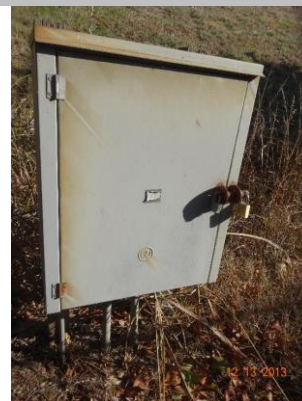
Photo 3 of 3 : UCIP\_SP\_2020\_29054\_53589.jpg

Control box located on landward toe.

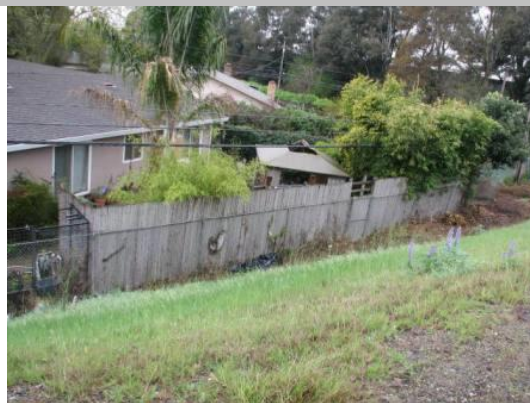
Photo 1 of 1 : SP\_2020\_NA0001\_55\_8\_20200302\_00006.jpg

LM Start	3.90	Rating **	U	Issue No.	8
LM End	3.90	Issue Type +	En	Location *	LS
Category	Earthen Levee			GPS Latitude/Longitude	
				Start	End
Item	Encroachments			38.586327 °	38.586327 °
				-121.447373 °	-121.447373 °
DWR ID	DWR_NA0001_04_s_2012_8				
Comment Code					
FE : Fence					
Inspector Comment					
A bamboo privacy fence within 10-ft of the landside toe obstructs visibility.

03/16/2012 Wood privacy fence completely obstructs access and visibility.

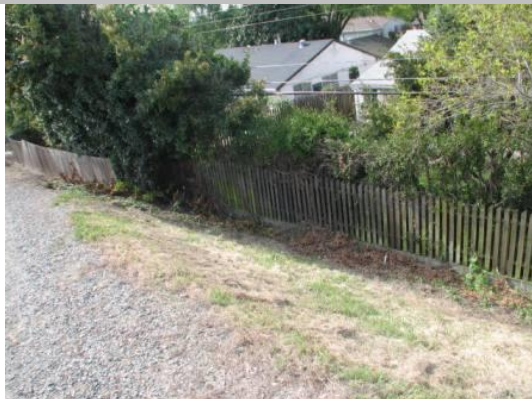
Photo 1 of 1 : SP\_2020\_NA0001\_55\_6\_20200302\_00005.jpg

LM Start	3.92	Rating **	U	Issue No.	6
LM End	3.92	Issue Type +	En	Location *	LS
Category	Earthen Levee			GPS Latitude/Longitude	
				Start	End
Item	Encroachments			38.586154 °	38.586154 °
				-121.447115 °	-121.447115 °
DWR ID	DWR_NA0001_04_s_2012_6				
Comment Code					
FE : Fence					
Inspector Comment					
A privacy fence within 10-ft of the landside toe obstructs visibility.

04/14/2011 Landscaping has been removed; however, a wooden fence is still obstructing access and visibility.

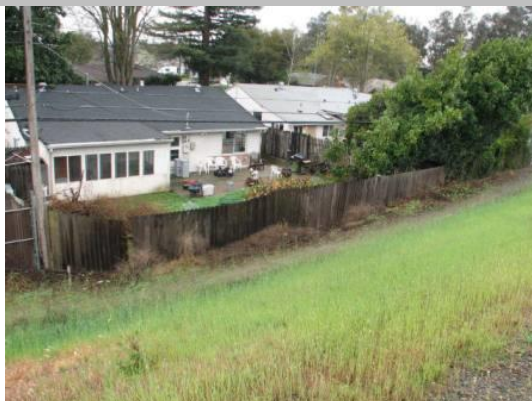
Photo 1 of 1 : SP\_2020\_NA0001\_55\_9\_20200302\_00007.jpg

LM Start	3.93	Rating **	U	Issue No.	9
LM End	3.93	Issue Type +	En	Location *	LS
Category	Earthen Levee			GPS Latitude/Longitude	
				Start	End
Item	Encroachments			38.586047 °	38.586047 °
				-121.446975 °	-121.446975 °
DWR ID	DWR_NA0001_04_s_2012_9				
Comment Code					
FE : Fence					
Inspector Comment					
A wooden privacy fence on the levee slope obstructs access and visibility.

03/16/2012 Wood privacy fence completely obstructs access and visibility.

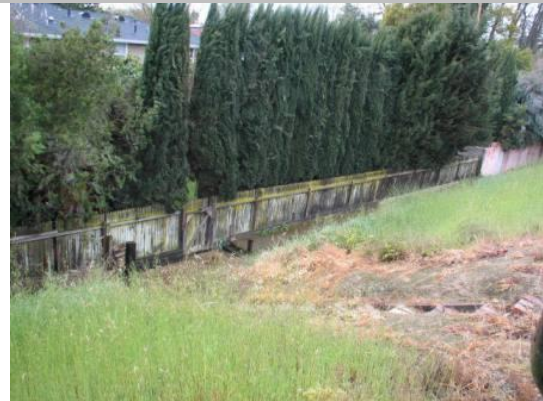
Photo 1 of 1 : SP\_2020\_NA0001\_55\_14\_20200302\_00010.jpg

LM Start	4.02	Rating **	U	Issue No.	14
LM End	4.02	Issue Type +	En	Location *	LS
Category	Earthen Levee			GPS Latitude/Longitude	
				Start	End
Item	Encroachments			38.585175 °	38.585175 °
				-121.445883 °	-121.445883 °
DWR ID	DWR_NA0001_04_s_2012_14				
Comment Code					
FE : Fence					
Inspector Comment					
A privacy fence and helix pencil shrubs planted within 10-ft of the levee toe obstruct access and visibility.

03/16/2012 Wood privacy fence completely obstructs access and visibility.

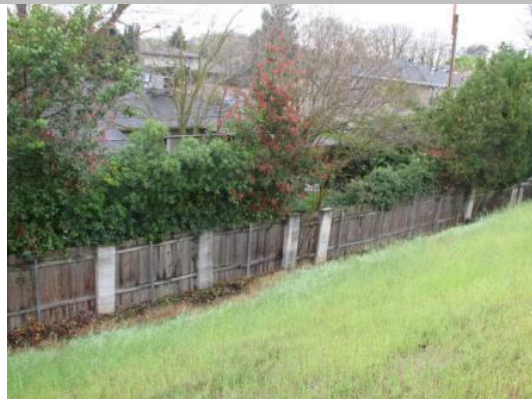
Photo 1 of 1 : SP\_2020\_NA0001\_55\_16\_20200302\_00012.jpg

LM Start	4.04	Rating **	U	Issue No.	16
LM End	4.04	Issue Type +	En	Location *	LS
Category	Earthen Levee			GPS Latitude/Longitude	
				Start	End
Item	Encroachments			38.584885 °	38.584885 °
				-121.445520 °	-121.445520 °
DWR ID	DWR_NA0001_04_f_2019_16				
Comment Code					
FE : Fence					
Inspector Comment					
A privacy fence and landscaping within 10-ft of the levee toe obstruct access and visibility.

03/16/2012 Wood privacy fence completely obstructs access and visibility.

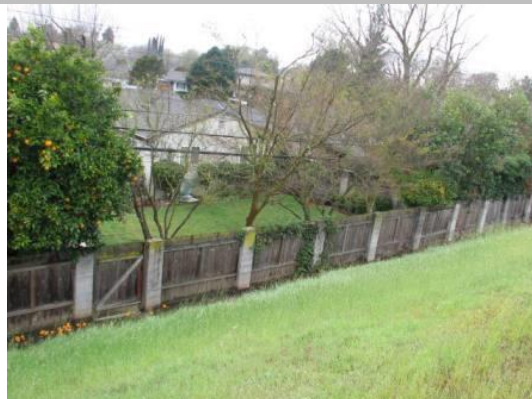
Photo 1 of 1 : SP\_2020\_NA0001\_55\_17\_20200302\_00013.jpg

LM Start	4.05	Rating **	U	Issue No.	17
LM End	4.05	Issue Type +	En	Location *	LS
Category	Earthen Levee			GPS Latitude/Longitude	
				Start	End
Item	Encroachments			38.584810 °	38.584810 °
				-121.445403 °	-121.445403 °
DWR ID	DWR_NA0001_04_f_2018_17				
Comment Code					
FE : Fence					
Inspector Comment					
A privacy fence and maple tree landscaping within 10-ft of the levee toe obstruct access and visibility. The fence and citrus tree appear to be unauthorized.

03/16/2012 Wood privacy fence completely obstructs access and visibility.

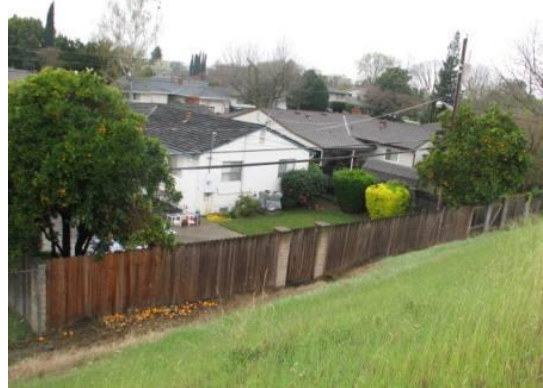
Photo 1 of 1 : SP\_2020\_NA0001\_55\_18\_20200302\_00014.jpg

LM Start	4.06	Rating **	U	Issue No.	18
LM End	4.06	Issue Type +	En	Location *	LS
Category	Earthen Levee			GPS Latitude/Longitude	
				Start	End
Item	Encroachments			38.584694 °	38.584694 °
				-121.445255 °	-121.445255 °
DWR ID	DWR_NA0001_04_s_2012_18				
Comment Code					
FE : Fence					
Inspector Comment					
A wooden fence between orange trees is within 10-ft of the levee toe.

03/16/2012 Wood privacy fence completely obstructs access and visibility.

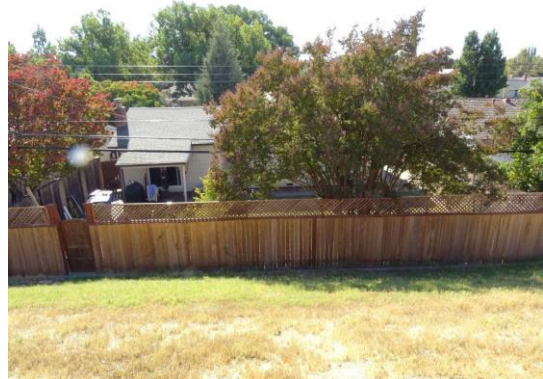
Photo 1 of 1 : SP\_2020\_NA0001\_55\_284\_20200302\_00203.jpg

LM Start	4.08	Rating **	U	Issue No.	284
LM End	4.08	Issue Type +	En	Location *	LS
Category	Earthen Levee			GPS Latitude/Longitude	
				Start	End
Item	Encroachments			38.584556 °	38.584556 °
				-121.445103 °	-121.445103 °
DWR ID	DWR_NA0001_04_f_2018_284				
Comment Code					
FE : Fence					
Inspector Comment					
A wooden fence on the levee toe blocks visibility and access.

View of wooden fence on levee toe. Fall 2018

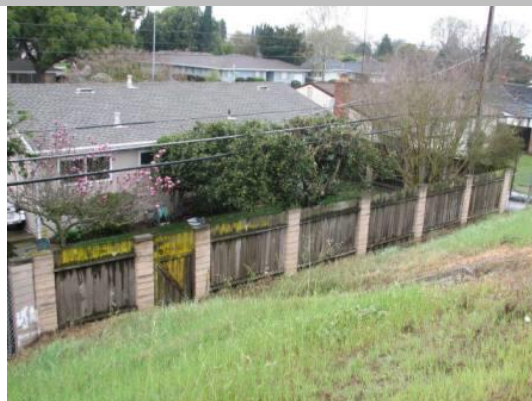
Photo 1 of 1 : SP\_2020\_NA0001\_55\_19\_20200302\_00015.jpg

LM Start	4.09	Rating **	U	Issue No.	19
LM End	4.09	Issue Type +	En	Location *	LS
Category	Earthen Levee			GPS Latitude/Longitude	
				Start	End
Item	Encroachments			38.584459 °	38.584459 °
				-121.444951 °	-121.444951 °
DWR ID	DWR_NA0001_04_s_2012_19				
Comment Code					
FE : Fence					
Inspector Comment					
A privacy fence within 10-ft of the levee toe obstructs access and visibility.

03/16/2012 Wood privacy fence completely obstructs access and visibility.

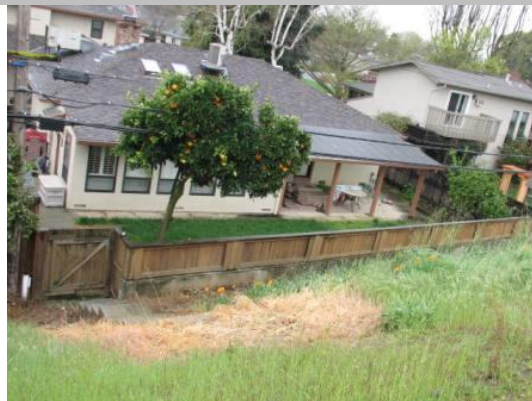
Photo 1 of 1 : SP\_2020\_NA0001\_55\_23\_20200302\_00019.jpg

LM Start	4.14	Rating **	U	Issue No.	23
LM End	4.14	Issue Type +	En	Location *	LS
Category	Earthen Levee			GPS Latitude/Longitude	
				Start	End
Item	Encroachments			38.583935 °	38.583935 °
				-121.444150 °	-121.444150 °
DWR ID	DWR_NA0001_04_s_2012_23				
Comment Code					
FE : Fence					
Inspector Comment					
A cement block and wooden fence obstruct visibility.

03/16/2012 Wooden fence on cement wall obstructs access and visibility.

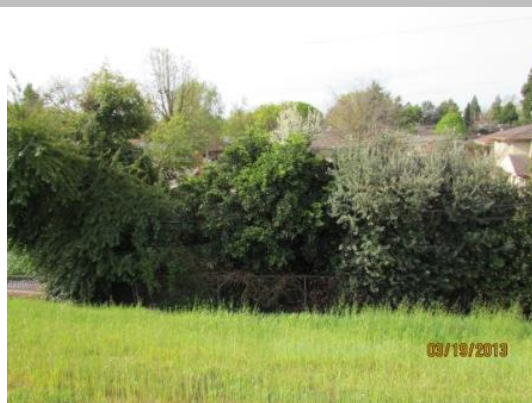
Photo 1 of 1 : SP\_2020\_NA0001\_55\_187\_20200302\_00150.jpg

LM Start	4.15	Rating **	M	Issue No.	187
LM End	4.15	Issue Type +	En	Location *	LS
Category	Earthen Levee			GPS Latitude/Longitude	
				Start	End
Item	Vegetation			38.583858 °	38.583858 °
				-121.443981 °	-121.443981 °
DWR ID	DWR_NA0001_04_s_2012_187				
Comment Code					
V6 : Landscaping					
Inspector Comment					
Orange, guava, and other trees and landscaping obstruct access and visibility.

View of the obstructing vegetation at levee toe.

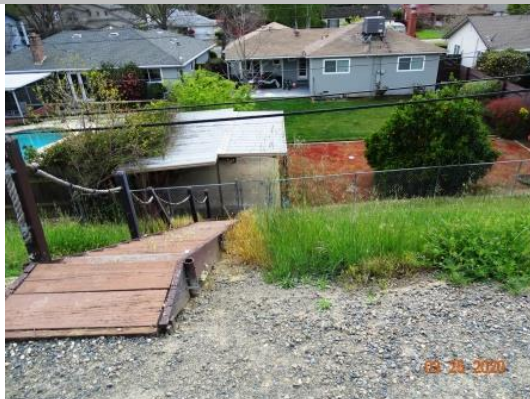
Photo 1 of 1 : SP\_2020\_NA0001\_55\_214\_20200326\_00259.jpg

LM Start	4.18	Rating **	M	Issue No.	214
LM End	4.18	Issue Type +	En	Location *	LS
Category	Earthen Levee			GPS Latitude/Longitude	
				Start	End
Item	Encroachments			38.583665 °	38.583665 °
				-121.443632 °	-121.443632 °
DWR ID	DWR_NA0001_04_s_2020_214				
Comment Code					
ST : Stairway					
Inspector Comment					
A cyclone fence on a retaining wall and an aluminum shed do not appear to be authorized.

View of a cyclone fence, a retaining wall, and an aluminum shed on the landside slope and toe. Spring 2020

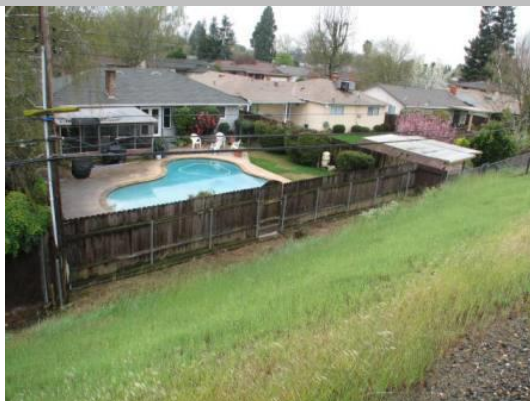
Photo 1 of 1 : SP\_2020\_NA0001\_55\_190\_20200302\_00152.jpg

LM Start	4.19	Rating **	U	Issue No.	190
LM End	4.19	Issue Type +	En	Location *	LS
Category	Earthen Levee			GPS Latitude/Longitude	
				Start	End
Item	Encroachments			38.583559 °	38.583559 °
				-121.443485 °	-121.443485 °
DWR ID	DWR_NA0001_04_s_2012_190				
Comment Code					
UR : Urban					
Inspector Comment					
Planter boxes are built into levee slope. A wooden fence obstructs visibility. A pool is just outside 10-ft from the levee toe.

03/16/2012 Wood privacy fence completely obstructs access and visibility.

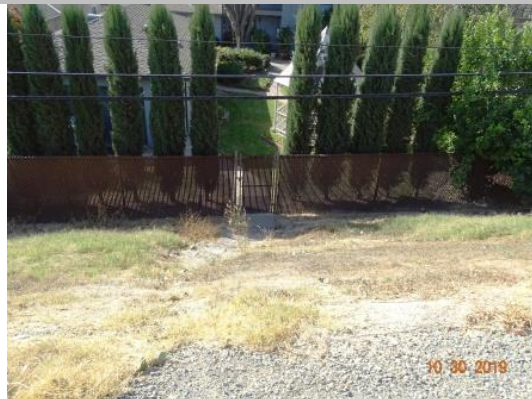
Photo 1 of 1 : SP\_2020\_NA0001\_55\_212\_20200302\_00171.jpg

LM Start	4.20	Rating **	M	Issue No.	212
LM End	4.20	Issue Type +	En	Location *	LS
Category	Earthen Levee			GPS Latitude/Longitude	
				Start	End
Item	Encroachments			38.583470 °	38.583470 °
				-121.443298 °	-121.443298 °
DWR ID	DWR_NA0001_04_f_2019_212				
Comment Code					
FE : Fence					
Inspector Comment					
A slatted fence at the levee toe and stone paver stairway do not appear to be authorized.

View of slatted fence at the levee toe and stone paver stairway. Fall 2019

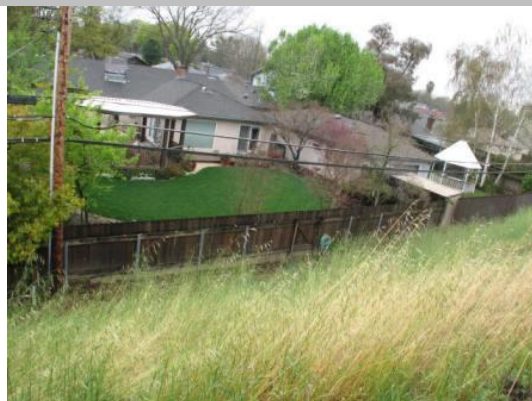
Photo 1 of 1 : SP\_2020\_NA0001\_55\_191\_20200302\_00153.jpg

LM Start	4.21	Rating **	U	Issue No.	191
LM End	4.21	Issue Type +	En	Location *	LS
Category	Earthen Levee			GPS Latitude/Longitude	
				Start	End
Item	Encroachments			38.583355 °	38.583355 °
				-121.443123 °	-121.443123 °
DWR ID	DWR_NA0001_04_s_2012_191				
Comment Code					
FE : Fence					
Inspector Comment					
A wooden privacy fence is within 10-ft of the levee toe and obstructs access and visibility.

03/16/2012 Wood privacy fence completely obstructs access and visibility.

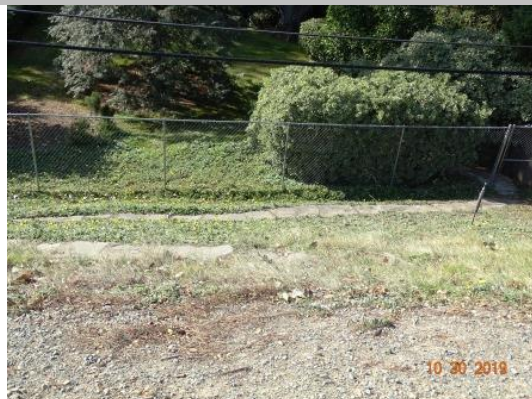
Photo 1 of 1 : SP\_2020\_NA0001\_55\_204\_20200302\_00162.jpg

LM Start	4.25	Rating **	M	Issue No.	204
LM End	4.25	Issue Type +	En	Location *	LS
Category	Earthen Levee			GPS Latitude/Longitude	
				Start	End
Item	Encroachments			38.583022 °	38.583022 °
				-121.442542 °	-121.442542 °
DWR ID	DWR_NA0001_04_f _ 2019_204				
Comment Code					
LI : Landscape Irrigation					
Inspector Comment					
Sprinklers do not appear to be authorized.

View of stone pavers and sprinklers on the landside slope. Fall 2019

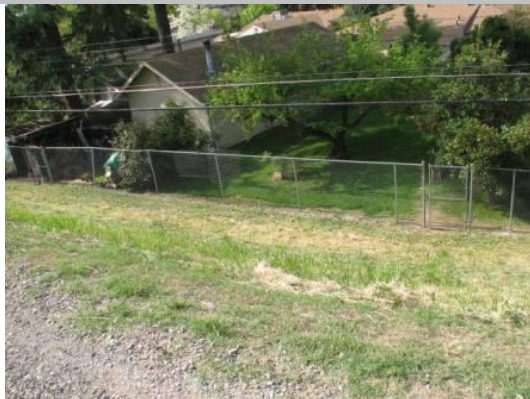
Photo 1 of 1 : SP\_2020\_NA0001\_55\_194\_20200302\_00155.jpg

LM Start	4.28	Rating **	M	Issue No.	194
LM End	4.28	Issue Type +	En	Location *	LS
Category	Earthen Levee			GPS Latitude/Longitude	
				Start	End
Item	Encroachments			38.582716 °	38.582716 °
				-121.442128 °	-121.442128 °
DWR ID	DWR_NA0001_04_s_2012_194				
Comment Code					
FE : Fence					
Inspector Comment					
A chainlink fence obstructs access and does not appear to be authorized.

04/14/2011 Planter boxes have been removed. Chainlink fence partially blocks access.

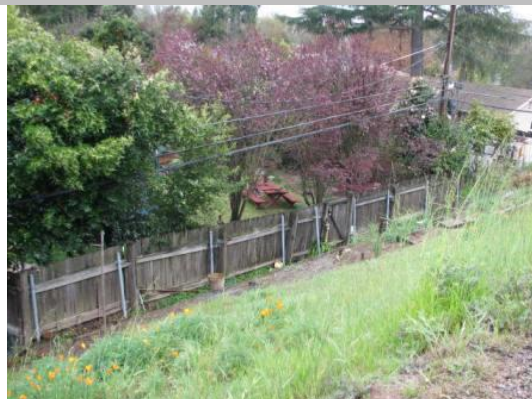
Photo 1 of 1 : SP\_2020\_NA0001\_55\_26\_20200302\_00021.jpg

LM Start	4.31	Rating **	M	Issue No.	26
LM End	4.31	Issue Type +	En	Location *	LS
Category	Earthen Levee			GPS Latitude/Longitude	
				Start	End
Item	Encroachments			38.582479 °	38.582479 °
				-121.441768 °	-121.441768 °
DWR ID	DWR_NA0001_04_s_2012_26				
Comment Code					
FE : Fence					
Inspector Comment					
A wooden fence is within 10-ft of the levee toe.

03/16/2012 Wood privacy fence completely obstructs access and visibility.

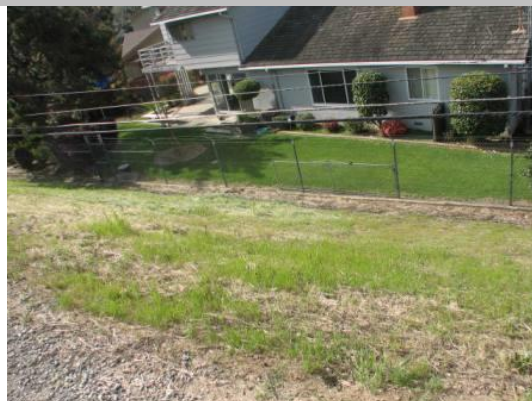
Photo 1 of 1 : SP\_2020\_NA0001\_55\_195\_20200302\_00156.jpg

LM Start	4.32	Rating **	M	Issue No.	195
LM End	4.32	Issue Type +	En	Location *	LS
Category	Earthen Levee			GPS Latitude/Longitude	
				Start	End
Item	Encroachments			38.582333 °	38.582333 °
				-121.441506 °	-121.441506 °
DWR ID	DWR_NA0001_04_s_2012_195				
Comment Code					
FE : Fence					
Inspector Comment					
There is a chainlink fence at the levee toe.

04/14/2011 Landscape removed, chainlink fence remains.

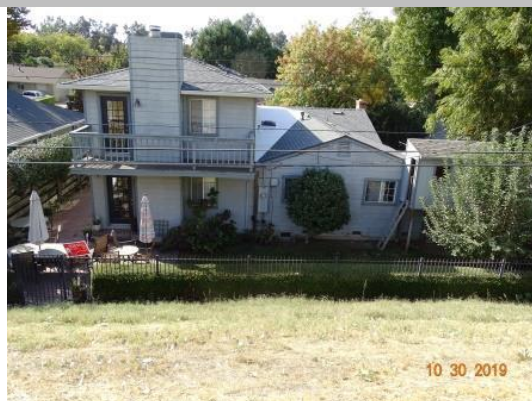
Photo 1 of 1 : SP\_2020\_NA0001\_55\_30\_20200302\_00025.jpg

LM Start	4.40	Rating **	M	Issue No.	30
LM End	4.40	Issue Type +	En	Location *	LS
Category	Earthen Levee			GPS Latitude/Longitude	
				Start	End
Item	Encroachments			38.581847 °	38.581847 °
				-121.440290 °	-121.440290 °
DWR ID	DWR_NA0001_04_f_2019_30				
Comment Code					
FE : Fence					
Inspector Comment					
The wrought iron fence does not appear to be authorized.

View of hedges and wrought iron fence at the levee toe. Fall 2019

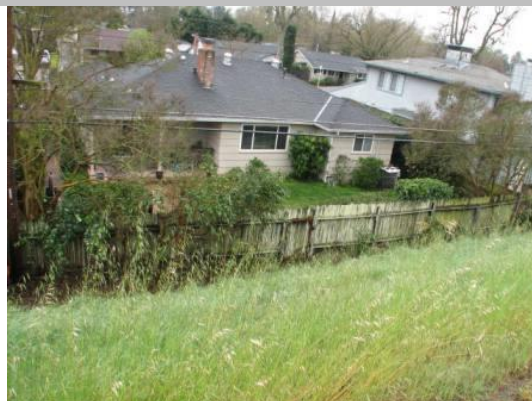
Photo 1 of 1 : SP\_2020\_NA0001\_55\_198\_20200302\_00157.jpg

LM Start	4.41	Rating **	U	Issue No.	198
LM End	4.41	Issue Type +	En	Location *	LS
Category	Earthen Levee			GPS Latitude/Longitude	
				Start	End
Item	Encroachments			38.581788 °	38.581788 °
				-121.440086 °	-121.440086 °
DWR ID	DWR_NA0001_04_s_2012_198				
Comment Code					
FE : Fence					
Inspector Comment					
Privacy fence and landscaping within 10-ft of the levee toe obstruct access and visibility.

03/16/2012 Wood privacy fence completely obstructs access and visibility.

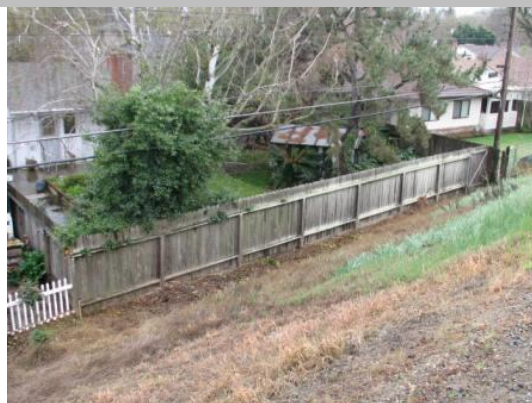
Photo 1 of 1 : SP\_2020\_NA0001\_55\_31\_20200302\_00026.jpg

LM Start	4.47	Rating **	U	Issue No.	31
LM End	4.47	Issue Type +	En	Location *	LS
Category	Earthen Levee			GPS Latitude/Longitude	
				Start	End
Item	Encroachments			38.581495 °	38.581495 °
				-121.439129 °	-121.439129 °
DWR ID	DWR_NA0001_04_s_2012_31				
Comment Code					
FE : Fence					
Inspector Comment					
A wooden fence within 10-ft of the levee toe obstructs access and visibility.

03/16/2012 Wood privacy fence completely obstructs access and visibility.

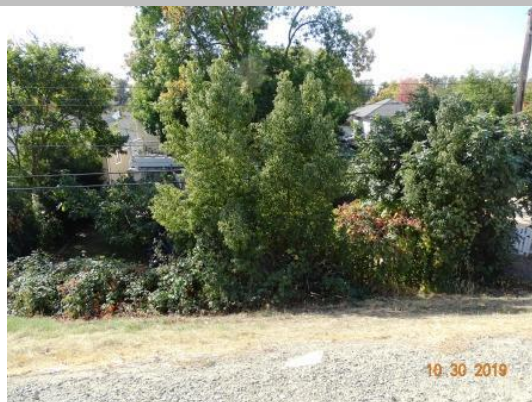
Photo 1 of 1 : SP\_2020\_NA0001\_55\_280\_20200302\_00202.jpg

LM Start	4.49	Rating **	M	Issue No.	280
LM End	4.49	Issue Type +	En	Location *	LS
Category	Earthen Levee			GPS Latitude/Longitude	
				Start	End
Item	Vegetation			38.581379 °	38.581379 °
				-121.438700 °	-121.438700 °
DWR ID	DWR_NA0001_04_f_2018_280				
Comment Code					
V6 : Landscaping					
Inspector Comment					
Vegetation on the fence blocks visibility of the levee toe. The wooden fence does not appear to be authorized.

View of landscaping that blocks visibility. Fall 2019

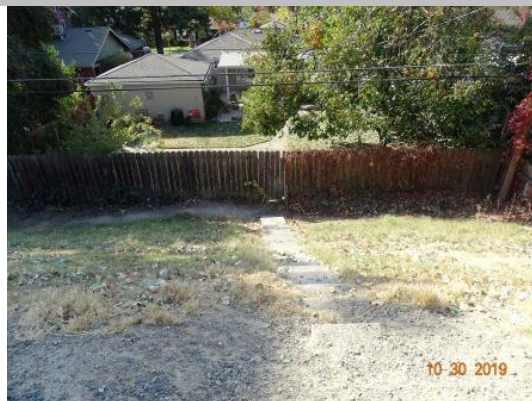
Photo 1 of 1 : SP\_2020\_NA0001\_55\_35\_20200302\_00027.jpg

LM Start	4.53	Rating **	U	Issue No.	35
LM End	4.53	Issue Type +	En	Location *	LS
Category	Earthen Levee			GPS Latitude/Longitude	
				Start	End
Item	Encroachments			38.581246 °	38.581246 °
				-121.438033 °	-121.438033 °
DWR ID	DWR_NA0001_04_s_2012_35				
Comment Code					
FE : Fence					
Inspector Comment					
A wooden fence within 10-ft of the levee toe obstructs access and visibility. Concrete steps also appear to be unauthorized.

View of wooden fence at the levee toe and concrete steps on the slope.  
Fall 2019

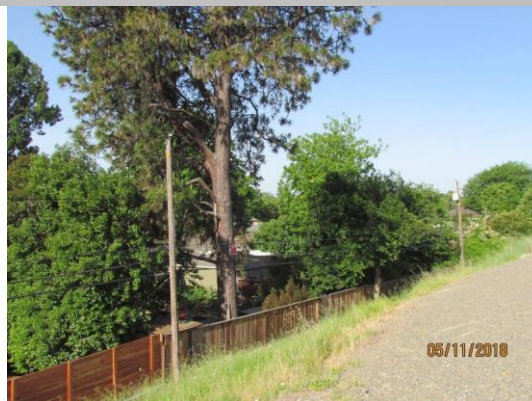
Photo 1 of 1 : SP\_2020\_NA0001\_55\_199\_20200302\_00158.jpg

LM Start	4.54	Rating **	U	Issue No.	199
LM End	4.54	Issue Type +	En	Location *	LS
Category	Earthen Levee			GPS Latitude/Longitude	
				Start	End
Item	Encroachments			38.581205 °	38.581205 °
				-121.437830 °	-121.437830 °
DWR ID	DWR_NA0001_04_s_2012_199				
Comment Code					
FE : Fence					
Inspector Comment					
Wood privacy fence completely obstructs access and visibility. Fruit tree also encroaches on the levee slope.

New wood privacy fence completely obstructs access and visibility,  
Spring 2018.

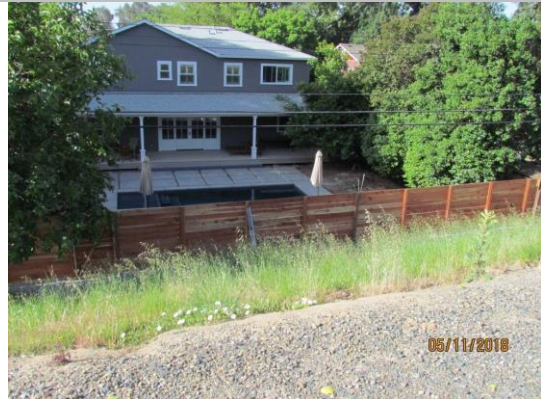
Photo 1 of 1 : SP\_2020\_NA0001\_55\_200\_20200302\_00160.jpg

LM Start	4.55	Rating **	U	Issue No.	200
LM End	4.55	Issue Type +	En	Location *	LS
Category	Earthen Levee			GPS Latitude/Longitude	
				Start	End
Item	Encroachments			38.581178 °	38.581178 °
				-121.437584 °	-121.437584 °
DWR ID	DWR_NA0001_04_s_2012_200				
Comment Code					
FE : Fence					
Inspector Comment					
Remodel, new pool, and new fence; the privacy fence on a concrete retaining wall completely obstructs access and visibility. The persimmon tree on the levee slope also appears to be unauthorized and blocks visibility.

View of the new remodel, new pool, and new fence; the privacy fence completely obstructs access and visibility, Spring 2018.

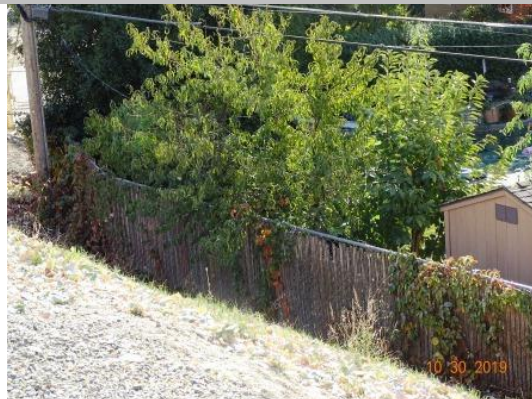
Photo 1 of 1 : SP\_2020\_NA0001\_55\_36\_20200302\_00028.jpg

LM Start	4.58	Rating **	U	Issue No.	36
LM End	4.58	Issue Type +	En	Location *	LS
Category	Earthen Levee			GPS Latitude/Longitude	
				Start	End
Item	Encroachments			38.581153 °	38.581153 °
				-121.437079 °	-121.437079 °
DWR ID	DWR_NA0001_04_f_2019_36				
Comment Code					
FE : Fence					
Inspector Comment					
A slatted fence near pump station limits access and visibility. A wooden shed also sits at the levee toe.

View of slatted fence and shed at the levee toe. Fall 2019

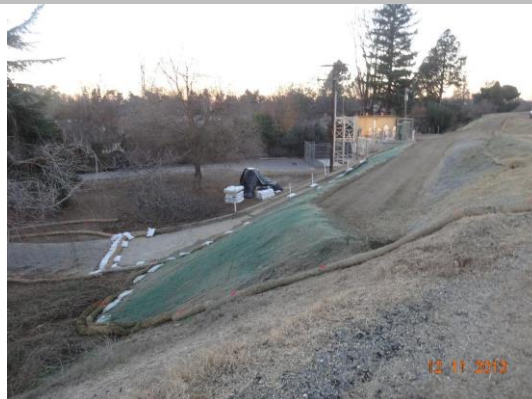
Photo 1 of 3 : UCIP\_SP\_2020\_31446\_57490.jpg

LM Start	4.61	Rating **	M	Issue No.	762
LM End	4.61	Issue Type +	En	Location *	
Category	Supplemental			GPS Latitude/Longitude	
				Start	End
Item	DWR UCIP Field Study			38.581101 °	38.581101 °
				-121.436502 °	-121.436502 °
DWR ID	24808				
Comment Code					
Inspector Comment					
DS_ID:24808					
FS_ID:31446					
EP_NO: N/A					
Repair Type: Non-Urgent					
Crossing Status: Indicator Found					
UCIP Comments: New construction--need permit and details on crossing.					
FIELD_STRUCT_DESC: 1 of 4: Concrete service box located on waterside (WS) shoulder. Landside (LS) has been regraded. No permit was found for the work. Unable to verify if crossing crosses levee.					
FS Date: 12/13/2013

View of landward side.

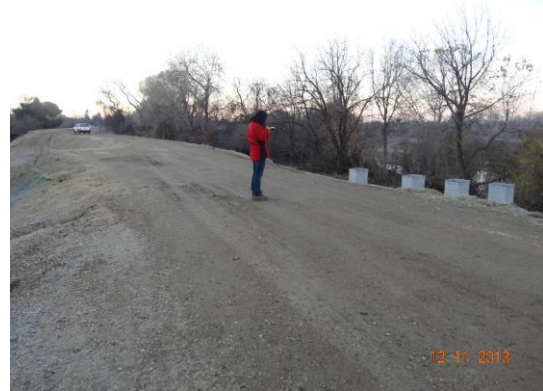
Photo 2 of 3 : UCIP\_SP\_2020\_31446\_57489.jpg

View of reggraded levee crown with service boxes on waterward slope.

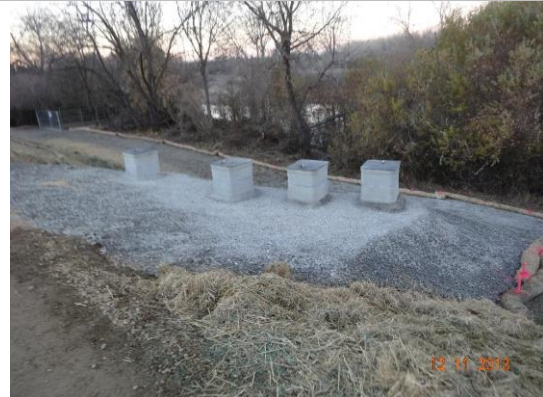
Photo 3 of 3 : UCIP\_SP\_2020\_31446\_57488.jpg

Service boxes located on waterward shoulder.

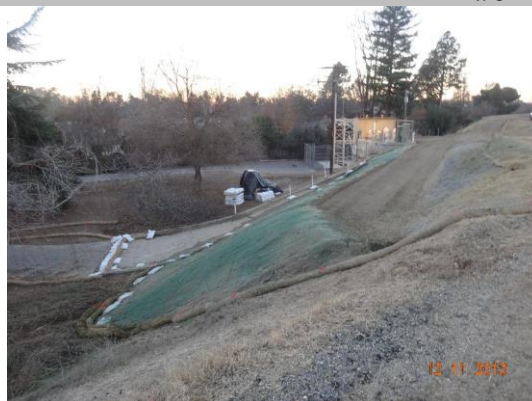
Photo 1 of 3 : UCIP\_SP\_2020\_31447\_57493.jpg

LM Start	4.61	Rating **	M	Issue No.	763
LM End	4.61	Issue Type +	En	Location *	
Category	Supplemental			GPS Latitude/Longitude	
				Start	End
Item	DWR UCIP Field Study			38.581092 °	38.581092 °
				-121.436466 °	-121.436466 °
DWR ID	24809				
Comment Code					
Inspector Comment					
DS_ID:24809 FS_ID:31447 EP_NO: N/A Repair Type: Non-Urgent Crossing Status: Indicator Found UCIP Comments: New construction; no permit found; Need additional information about crossings to determine whether crossings penetrate levee. FIELD_STRUCT_DESC: 2 of 4: Concrete service box located on waterside (WS) shoulder. Landside (LS) has been regraded. No permit was found for the work. Unable to verify if crossing crosses levee. FS Date: 12/13/2013

View of landward side.

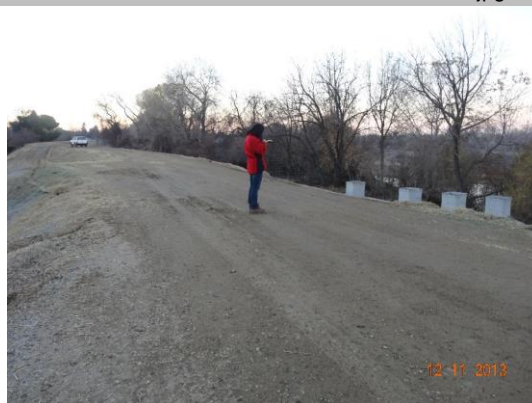
Photo 2 of 3 : UCIP\_SP\_2020\_31447\_57492.jpg

View of levee crown at crossings.

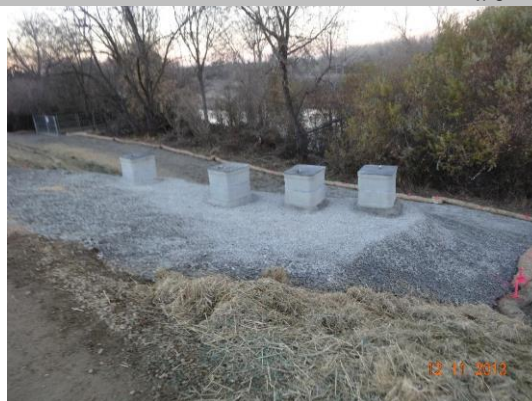
Photo 3 of 3 : UCIP\_SP\_2020\_31447\_57491.jpg

View of waterward side.

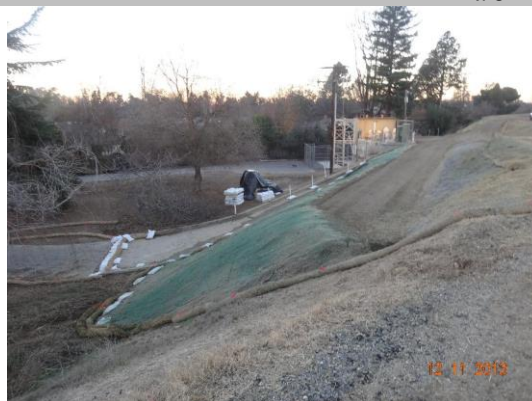
Photo 1 of 3 : UCIP\_SP\_2020\_31448\_57496.jpg

DS\_ID:24810  
 FS\_ID:31448  
 EP\_NO: N/A  
 Repair Type: Non-Urgent  
 Crossing Status: Indicator Found  
 UCIP Comments: New construction; no permit found; Need additional information about crossings to determine whether crossings penetrate levee.  
 FIELD\_STRUCT\_DESC: 3 of 4: Concrete service box located on waterside (WS) shoulder. Landside (LS) has been regraded. No permit was found for the work. Unable to verify if crossing crosses levee.  
 FS Date: 12/13/2013

View of landward side.

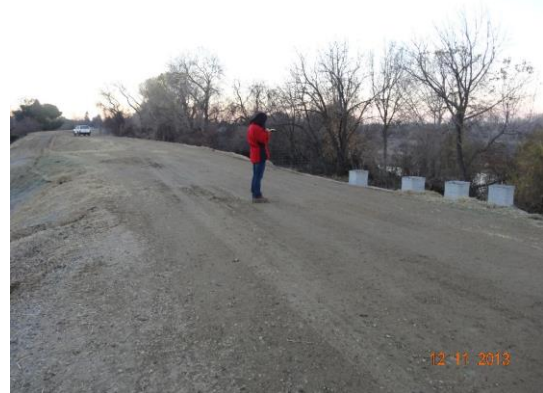
Photo 2 of 3 : UCIP\_SP\_2020\_31448\_57495.jpg

View of levee crown.

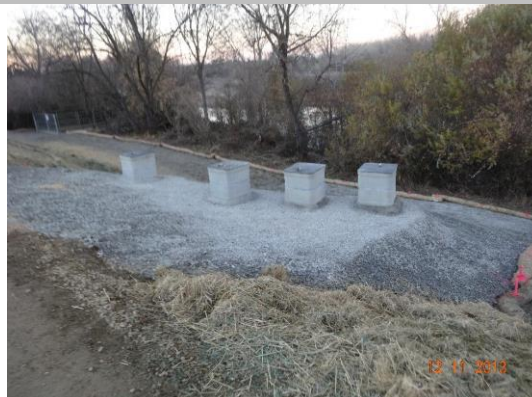
Photo 3 of 3 : UCIP\_SP\_2020\_31449\_57497.jpg

LM Start	4.61	Rating **	M	Issue No.	765
LM End	4.61	Issue Type +	En	Location *	
Category	Supplemental			GPS Latitude/Longitude	
				Start	End
Item	DWR UCIP Field Study			38.581082 °	38.581082 °
				-121.436431 °	-121.436431 °
DWR ID	24811				
Comment Code					
Inspector Comment					
DS_ID:24811 FS_ID:31449 EP_NO: N/A Repair Type: Non-Urgent Crossing Status: Indicator Found UCIP Comments: New construction; no permit found; Need additional information about crossings to determine whether crossing penetrate levee. FIELD_STRUCT_DESC: 4 of 4: Concrete service box located on waterside (WS) shoulder. Landside (LS) has been regraded. No permit was found for the work. Unable to verify if crossing crosses levee. FS Date: 12/13/2013

View of landward side--service boxes located on landward slope.

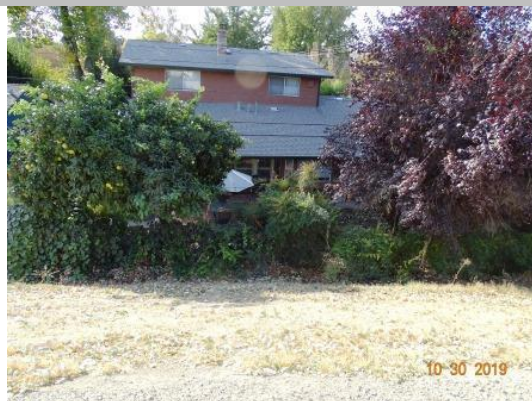
Photo 1 of 1 : SP\_2020\_NA0001\_55\_182\_20200302\_00147.jpg

LM Start	4.66	Rating **	M	Issue No.	182
LM End	4.66	Issue Type +	En	Location *	LS
Category	Earthen Levee			GPS Latitude/Longitude	
				Start	End
Item	Vegetation			38.580883 °	38.580883 °
				-121.435635 °	-121.435635 °
DWR ID	DWR_NA0001_04_f_2019_182				
Comment Code					
V6 : Landscaping					
Inspector Comment					
The wire fence with vegetation and citrus tree at the levee toe appear to be unauthorized and block visibility and access.

View of landscaping at the levee toe. Fall 2019

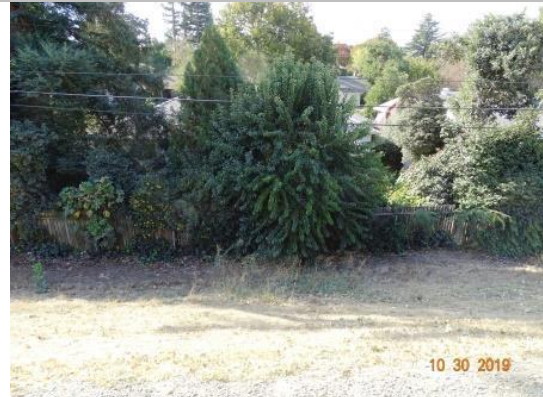
Photo 1 of 1 : SP\_2020\_NA0001\_55\_39\_20200302\_00029.jpg

LM Start	4.70	Rating **	M	Issue No.	39
LM End	4.70	Issue Type +	En	Location *	LS
Category	Earthen Levee			GPS Latitude/Longitude	
				Start	End
Item	Vegetation			38.580840 °	38.580840 °
				-121.434901 °	-121.434901 °
DWR ID	DWR_NA0001_04_s_2012_39				
Comment Code					
V6 : Landscaping					
Inspector Comment					
Landscaping within 10-ft of the levee toe obstruct access and visibility.

View of landscaping at the levee toe that blocks visibility. Fall 2019

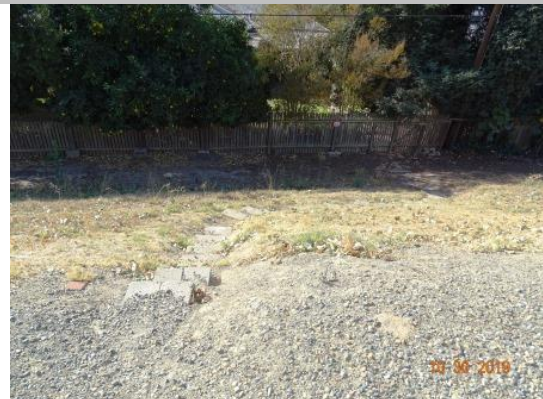
Photo 1 of 1 : SP\_2020\_NA0001\_55\_181\_20200302\_00146.jpg

LM Start	4.71	Rating **	M	Issue No.	181
LM End	4.71	Issue Type +	En	Location *	LS
Category	Earthen Levee			GPS Latitude/Longitude	
				Start	End
Item	Encroachments			38.580782 °	38.580782 °
				-121.434703 °	-121.434703 °
DWR ID	DWR_NA0001_04_f _ 2019_181				
Comment Code					
ST : Stairway					
Inspector Comment					
Concrete steps appear to be unauthorized.

View of concrete steps on the landside slope. Fall 2019

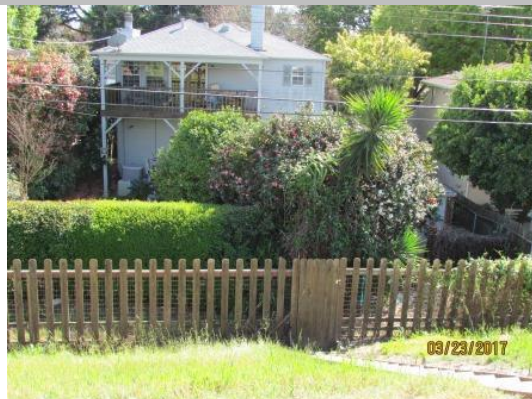
Photo 1 of 1 : SP\_2020\_NA0001\_55\_41\_20200302\_00031.jpg

LM Start	4.74	Rating **	M	Issue No.	41
LM End	4.74	Issue Type +	En	Location *	LS
Category	Earthen Levee			GPS Latitude/Longitude	
				Start	End
Item	Encroachments			38.580753 °	38.580753 °
				-121.434077 °	-121.434077 °
DWR ID	DWR_NA0001_04_s_2012_41				
Comment Code					
FE : Fence					
Inspector Comment					
Landscaping within 10-ft of the levee toe obstruct access and visibility.

View of the fence at the levee toe.

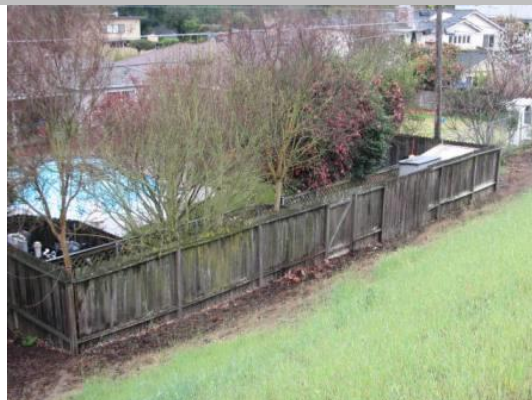
Photo 1 of 1 : SP\_2020\_NA0001\_55\_43\_20200302\_00033.jpg

LM Start	4.78	Rating **	U	Issue No.	43
LM End	4.78	Issue Type +	En	Location *	LS
Category	Earthen Levee			GPS Latitude/Longitude	
				Start	End
Item	Encroachments			38.580731 °	38.580731 °
				-121.433490 °	-121.433490 °
DWR ID	DWR_NA0001_04_s_2012_43				
Comment Code					
FE : Fence					
Inspector Comment					
A fence and storage sheds within 10-ft of the levee toe obstruct access and visibility.

03/16/2012 Wood privacy fence completely obstructs access and visibility.

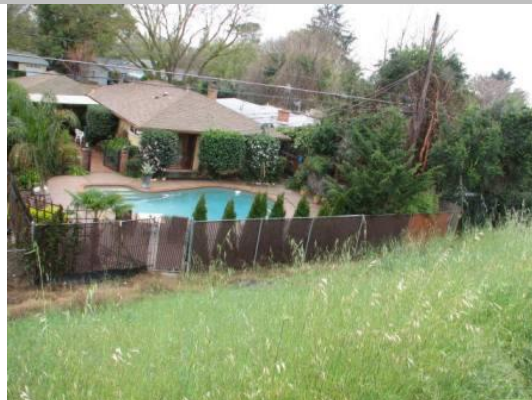
Photo 1 of 1 : SP\_2020\_NA0001\_55\_205\_20200302\_00163.jpg

LM Start	4.82	Rating **	U	Issue No.	205
LM End	4.82	Issue Type +	En	Location *	LS
Category	Earthen Levee			GPS Latitude/Longitude	
				Start	End
Item	Encroachments			38.580680 °	38.580680 °
				-121.432633 °	-121.432633 °
DWR ID	DWR_NA0001_04_s_2012_205				
Comment Code					
FE : Fence					
Inspector Comment					
A privacy fence at the levee toe obstructs access and visibility.

03/16/2012 Chainlink fence with privacy slats obstructs visibility and access.

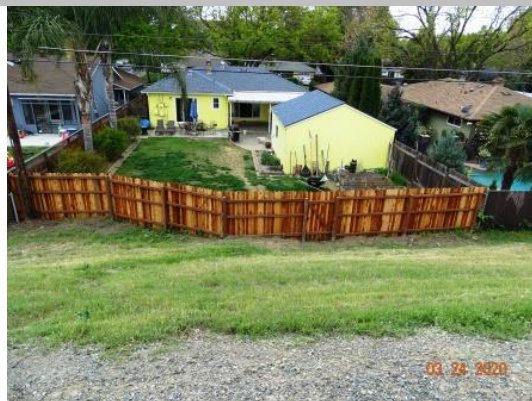
Photo 1 of 1 : SP\_2020\_NA0001\_55\_177\_20200427\_00274.jpg

LM Start	4.83	Rating **	M	Issue No.	177
LM End	4.83	Issue Type +	En	Location *	LS
Category	Earthen Levee			GPS Latitude/Longitude	
				Start	End
Item	Encroachments			38.580713 °	38.580713 °
				-121.432417 °	-121.432417 °
DWR ID	DWR_NA0001_04_f _ 2019_177				
Comment Code					
FE : Fence					
Inspector Comment					
A wooden fence alignment jogs into the landside toe.

View of a wooden fence at the levee toe. Spring 2020

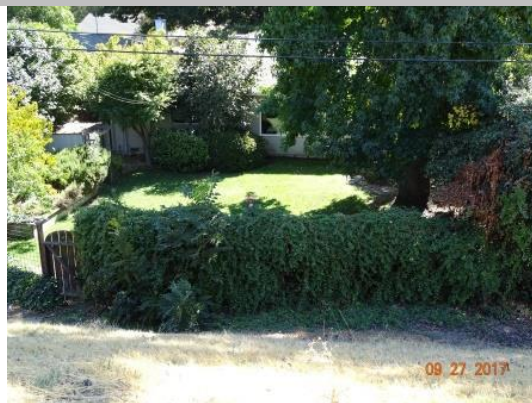
Photo 1 of 1 : SP\_2020\_NA0001\_55\_44\_20200302\_00034.jpg

LM Start	4.85	Rating **	M	Issue No.	44
LM End	4.85	Issue Type +	En	Location *	LS
Category	Earthen Levee			GPS Latitude/Longitude	
				Start	End
Item	Vegetation			38.580747 °	38.580747 °
				-121.432039 °	-121.432039 °
DWR ID	DWR_NA0001_04_f _ 2018_44				
Comment Code					
V6 : Landscaping					
Inspector Comment					
Vines on wire fence obstruct visibility.

View of the landscaping at the levee toe. Fall 2017

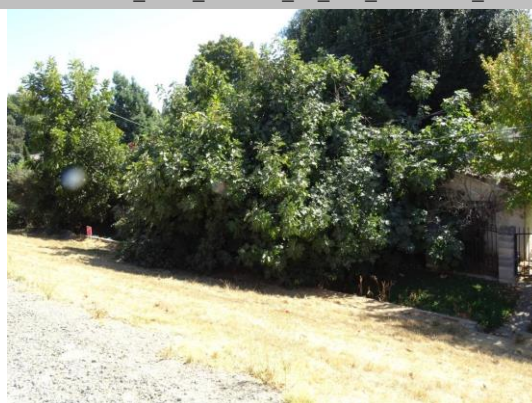
Photo 1 of 1 : SP\_2020\_NA0001\_55\_206\_20200302\_00164.jpg

LM Start	4.87	Rating **	U	Issue No.	206
LM End	4.87	Issue Type +	En	Location *	LS
Category	Earthen Levee			GPS Latitude/Longitude	
				Start	End
Item	Vegetation			38.580778 °	38.580778 °
				-121.431704 °	-121.431704 °
DWR ID	DWR_NA0001_04_s_2012_206				
Comment Code					
V6 : Landscaping					
Inspector Comment					
Fig tree obstructs visibility and access.

View of landscaping that obstructs visibility and access. Fall 2018

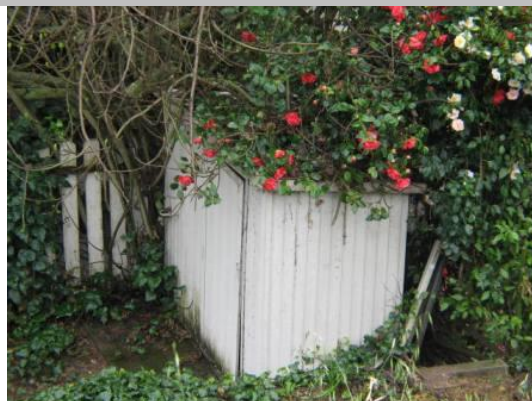
Photo 1 of 1 : SP\_2020\_NA0001\_55\_96\_20200302\_00076.jpg

LM Start	4.87	Rating **	U	Issue No.	96
LM End	4.87	Issue Type +	En	Location *	LS
Category	Earthen Levee			GPS Latitude/Longitude	
				Start	End
Item	Encroachments			38.580767 °	38.580767 °
				-121.431684 °	-121.431684 °
DWR ID	DWR_NA0001_04_s_2012_96				
Comment Code					
BU : Building					
Inspector Comment					
Wooden/corrugated metal shed is located within the levee easement beneath the fig tree.

3/16/2012 Structure is within 15' of levee toe.

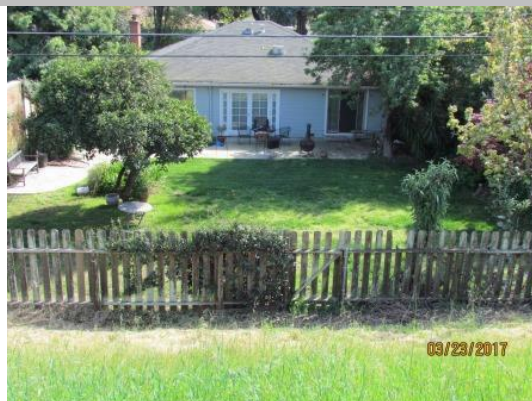
Photo 1 of 1 : SP\_2020\_NA0001\_55\_265\_20200302\_00198.jpg

LM Start	4.89	Rating **	M	Issue No.	265
LM End	4.89	Issue Type +	En	Location *	LS
Category	Earthen Levee			GPS Latitude/Longitude	
				Start	End
Item	Encroachments			38.580794 °	38.580794 °
				-121.431453 °	-121.431453 °
DWR ID	DWR_NA0001_04_s_2017_265				
Comment Code					
FE : Fence					
Inspector Comment					
A fence is located at the levee toe.

View of the fence at the levee toe.

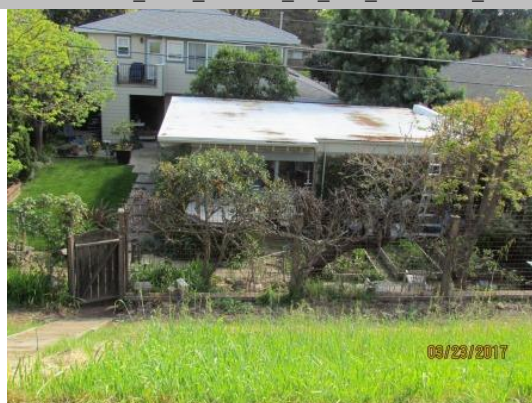
Photo 1 of 1 : SP\_2020\_NA0001\_55\_207\_20200302\_00166.jpg

LM Start	4.90	Rating **	M	Issue No.	207
LM End	4.90	Issue Type +	En	Location *	LS
Category	Earthen Levee			GPS Latitude/Longitude	
				Start	End
Item	Encroachments			38.580806 °	38.580806 °
				-121.431266 °	-121.431266 °
DWR ID	DWR_NA0001_04_s_2012_207				
Comment Code					
FE : Fence					
Inspector Comment					
A wire fence located at the levee toe and wooden stairs on the landside slope appear to be unauthorized.

View of the fence at the levee toe.

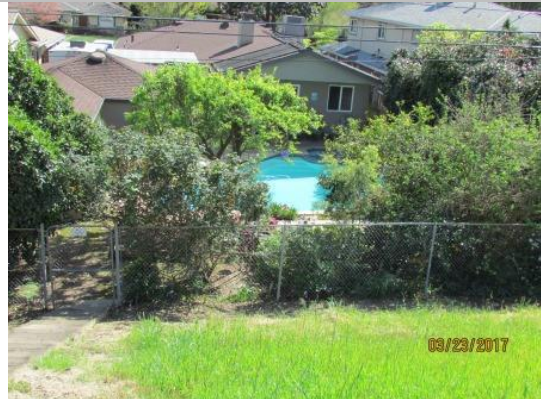
Photo 1 of 1 : SP\_2020\_NA0001\_55\_264\_20200302\_00197.jpg

LM Start	4.91	Rating **	M	Issue No.	264
LM End	4.91	Issue Type +	En	Location *	LS
Category	Earthen Levee			GPS Latitude/Longitude	
				Start	End
Item	Encroachments			38.580820 °	38.580820 °
				-121.431045 °	-121.431045 °
DWR ID	DWR_NA0001_04_s_2017_264				
Comment Code					
FE : Fence					
Inspector Comment					
A chain-link fence and citrus tree located at the levee toe appear to be unauthorized.

View of the fence at the levee toe.

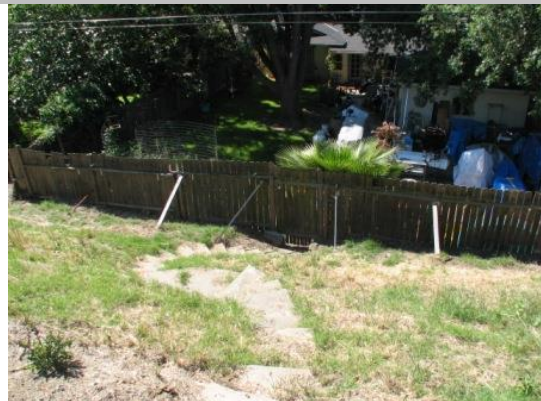
Photo 1 of 1 : SP\_2020\_NA0001\_55\_45\_20200302\_00035.jpg

LM Start	4.93	Rating **	U	Issue No.	45
LM End	4.93	Issue Type +	En	Location *	LS
Category	Earthen Levee			GPS Latitude/Longitude	
				Start	End
Item	Encroachments			38.580844 °	38.580844 °
				-121.430672 °	-121.430672 °
DWR ID	DWR_NA0001_04_s_2012_45				
Comment Code					
FE : Fence					
Inspector Comment					
A wooden fence with bracing obstructs access and visibility.

Wooden fence and braces obstruct access and visibility.

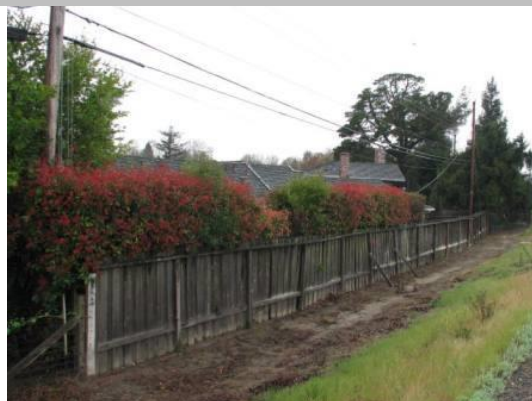
Photo 1 of 1 : SP\_2020\_NA0001\_55\_46\_20200302\_00036.jpg

LM Start	5.08	Rating **	U	Issue No.	46
LM End	5.09	Issue Type +	En	Location *	LS
Category	Earthen Levee			GPS Latitude/Longitude	
				Start	End
Item	Encroachments			38.581000 °	38.581073 °
				-121.427826 °	-121.427765 °
DWR ID	DWR_NA0001_04_s_2012_46				
Comment Code					
FE : Fence					
Inspector Comment					
A fence and landscaping within 10-ft of the levee toe obstruct access and visibility.

03/16/2012 Wood privacy fence completely obstructs access and visibility.

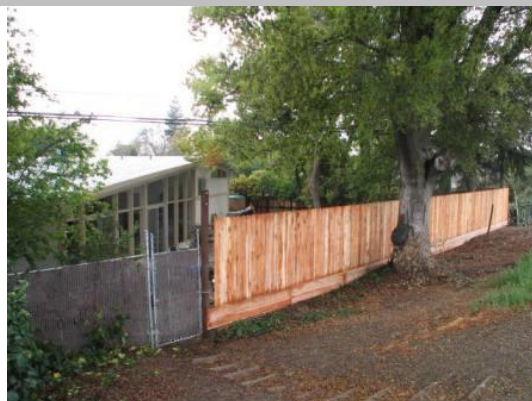
Photo 1 of 1 : SP\_2020\_NA0001\_55\_208\_20200302\_00167.jpg

LM Start	5.13	Rating **	U	Issue No.	208
LM End	5.13	Issue Type +	En	Location *	LS
Category	Earthen Levee			GPS Latitude/Longitude	
				Start	End
Item	Encroachments			38.580882 °	38.580882 °
				-121.427038 °	-121.427038 °
DWR ID	DWR_NA0001_04_s_2012_208				
Comment Code					
FE : Fence					
Inspector Comment					
A privacy fence with lattice and landscaping within 10-ft of the levee toe obstruct access and visibility.

03/16/2012 Wood privacy fence completely obstructs access and visibility.

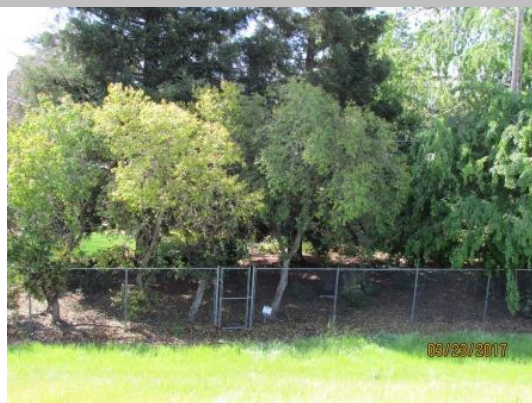
Photo 1 of 1 : SP\_2020\_NA0001\_55\_263\_20200302\_00196.jpg

LM Start	5.48	Rating **	M	Issue No.	263
LM End	5.48	Issue Type +	En	Location *	LS
Category	Earthen Levee			GPS Latitude/Longitude	
				Start	End
Item	Encroachments			38.577065 °	38.577065 °
				-121.423255 °	-121.423255 °
DWR ID	DWR_NA0001_04_s_2017_263				
Comment Code					
FE : Fence					
Inspector Comment					
Chain-link fence at levee toe does not appear to be permitted.

View of the fence at the levee toe.

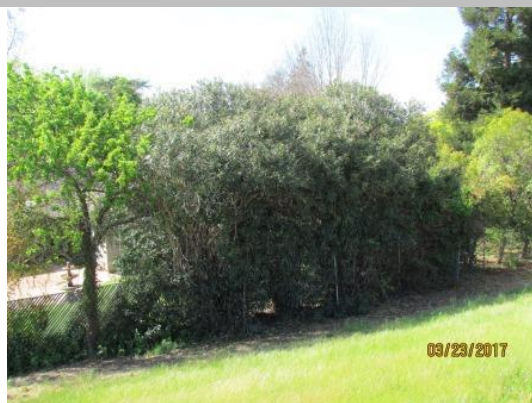
Photo 1 of 1 : SP\_2020\_NA0001\_55\_209\_20200302\_00168.jpg

LM Start	5.49	Rating **	M	Issue No.	209
LM End	5.49	Issue Type +	En	Location *	LS
Category	Earthen Levee			GPS Latitude/Longitude	
				Start	End
Item	Vegetation			38.576878 °	38.576878 °
				-121.423234 °	-121.423234 °
DWR ID	DWR_NA0001_04_s_2012_209				
Comment Code					
V6 : Landscaping					
Inspector Comment					
Oleanders within 10-ft of the levee toe obstruct access and visibility.

View of the shrubs at the levee toe.
